# Medical Devices: The Therac-25\*

Nancy Leveson  
University of Washington

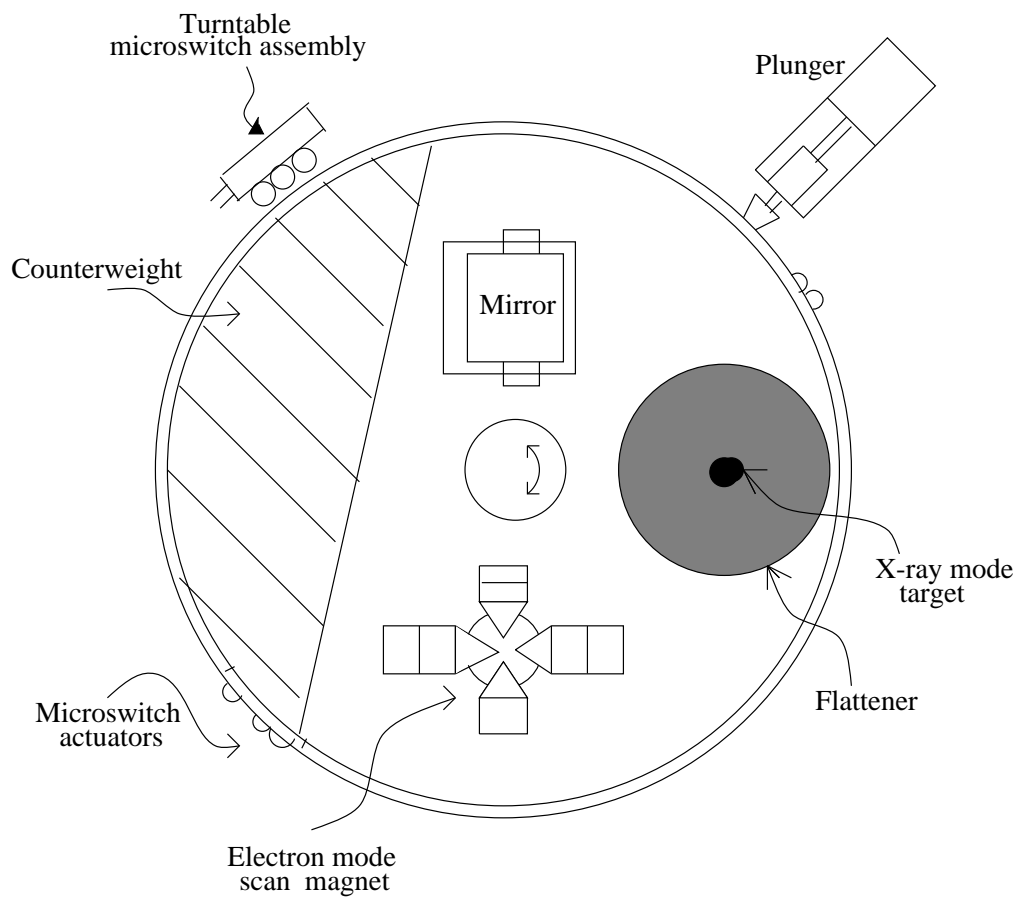
Figure 1: Upper turntable assembly.

**Turntable Positioning.** The Therac-25 turntable design plays an important role in the accidents. The upper turntable (see Figure 1) rotates accessory equipment into the beam path to produce two therapeutic modes: electron mode and photon mode. A third position (called the field light position) involves no beam at all, but rather is used to facilitate correct positioning of the patient. Because the accessories appropriate to each mode

are physically attached to the turntable, proper operation of the Therac-25 is heavily dependent on the turntable position, which is monitored by three microswitches.

In the Therac-25, the computer is responsible for positioning the turntable (and for checking the turntable position) so that a target, flattening filter, and X-ray ion chamber are directly in the beam path. With the target in place, electron bombardment produces X-rays. The X-ray beam is shaped by the flattening filter and measured by the X-ray ion chamber.

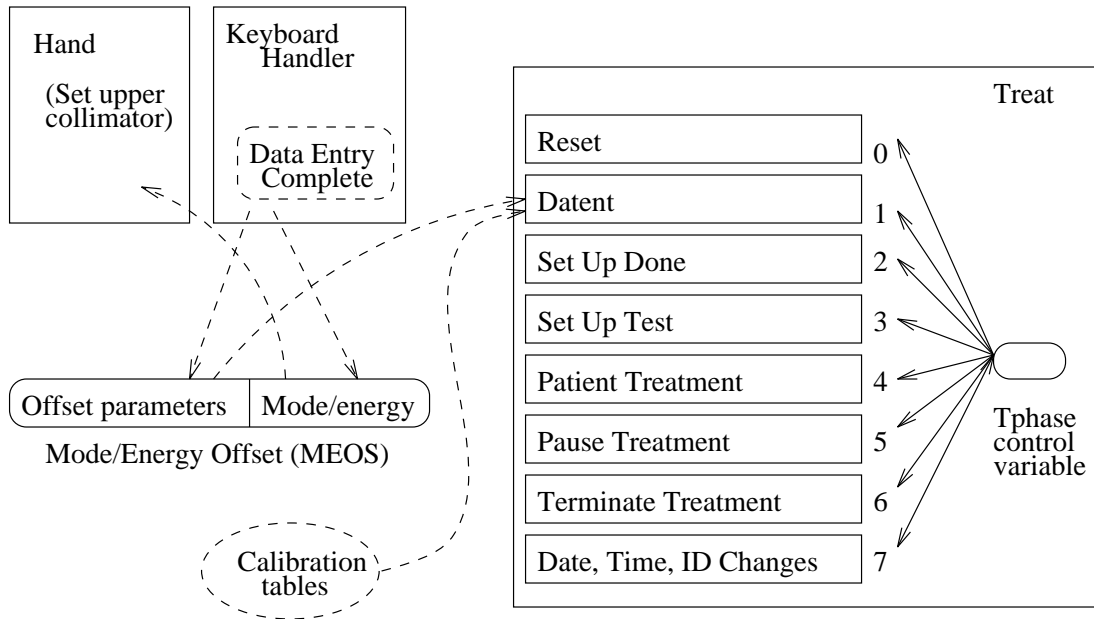
Figure 3: Tasks and subroutines in the code blamed for the Tyler accidents.

The treatment monitor task (Treat) controls the various phases of treatment by executing its eight subroutines. The treatment phase indicator variable (Tphase) is used to determine which subroutine should be executed (Figure 3). Following the execution of a particular subroutine, Treat reschedules itself.

One of Treat's subroutines, called Datent (data entry), communicates with the keyboard handler task (a task that runs concurrently with Treat) via a shared variable (Data Entry Complete flag) to determine whether the prescription data has been entered. The keyboard handler recognizes the completion of data entry and changes the Data Entry Complete variable to denote this. Once this variable is set, the Datent subroutine detects the variable's change in status and changes the value of Tphase from 1 (Datent) to 3 (Set Up Test). In this case, the Datent subroutine exits back to the Treat subroutine, which will reschedule itself and begin execution of the Set Up Test subroutine. If the Data Entry Complete variable has not been set, Datent leaves the value of Tphase unchanged and exits back to Treat's

Recall that the Tyler error occurred when the operator made an entry indicating the mode and energy, went to the command line, then moved the cursor up to change the mode or energy and returned to the command line all within eight seconds. Because the magnet setting takes about eight seconds and Magnet does not recognize edits after the first execution of Ptime, the editing had been completed by the return to Datent, which never detected that it had occurred. Part of the problem was fixed after the accident by clearing the bending magnet variable at the end of Magnet (after *all* the magnets have been set) instead of at the end of Ptime.

But this is not the only problem. Upon exit from the Magnet subroutine, the data entry subroutine (Datent) checks the Data Entry Complete variable. If it indicates that data entry is complete, Datent sets Tphase to 3 and Datent is not entered again. If it is not set, Datent leaves Tphase unchanged, which means it will eventually be rescheduled. But the Data Entry Complete variable only indicates that the cursor has been down to the command line, not that it is still there. A potential race condition is set up. To fix this, AECL introduced another shared variable controlled by the keyboard handler task that indicates the cursor is not positioned on the command line. If this variable is set, then prescription entry is still in progress and the value of Tphase is left unchanged.

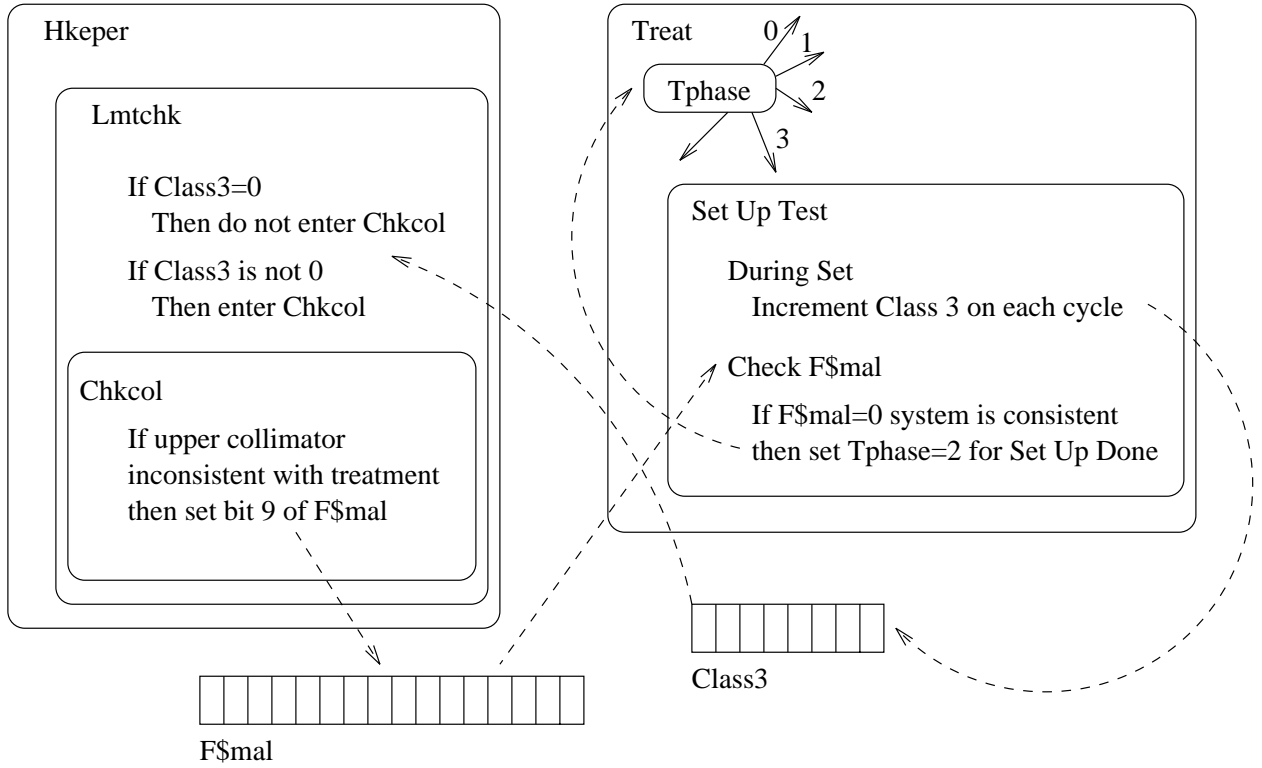
Figure 4: The Yakima software flaw.

In the software, after the prescription is entered and verified by the Datient routine, the control variable Tphase is changed so that the Set Up Test routine is entered (Figure 4). Every pass through the Set Up Test rou-

During machine setup, Set Up Test will be executed several hundred times because it reschedules itself waiting for other events to occur. In the code, the Class3 variable is incremented by one in each pass through Set Up Test. Since the Class3 variable is one byte, it can only contain a maximum value of 255 decimal. Thus, on every 256th pass through the Set Up Test code, the variable will overflow and have a zero value. That means that on every 256th pass through Set Up Test, the upper collimator will not be checked and an upper collimator fault will not be detected.

The overexposure occurred when the operator hit the “set” button at the precise moment that Class3 rolled over to zero. Thus, Chkcol was not executed and F\$mal was not set to indicate that the upper collimator was still in the field-light position. The software turned on the full 25 MeV without the target in place and without scanning. A highly concentrated electron beam resulted, which was scattered and deflected by the stainless

The technical “fix” implemented for this particular software flaw is described by AECL as simple: the program is changed so that the Class3 variable is set to some fixed nonzero value each time through Set Up Test instead of being incremented.
