Medical Devices: The Therac-25*

Nancy Leveson
University of Washington

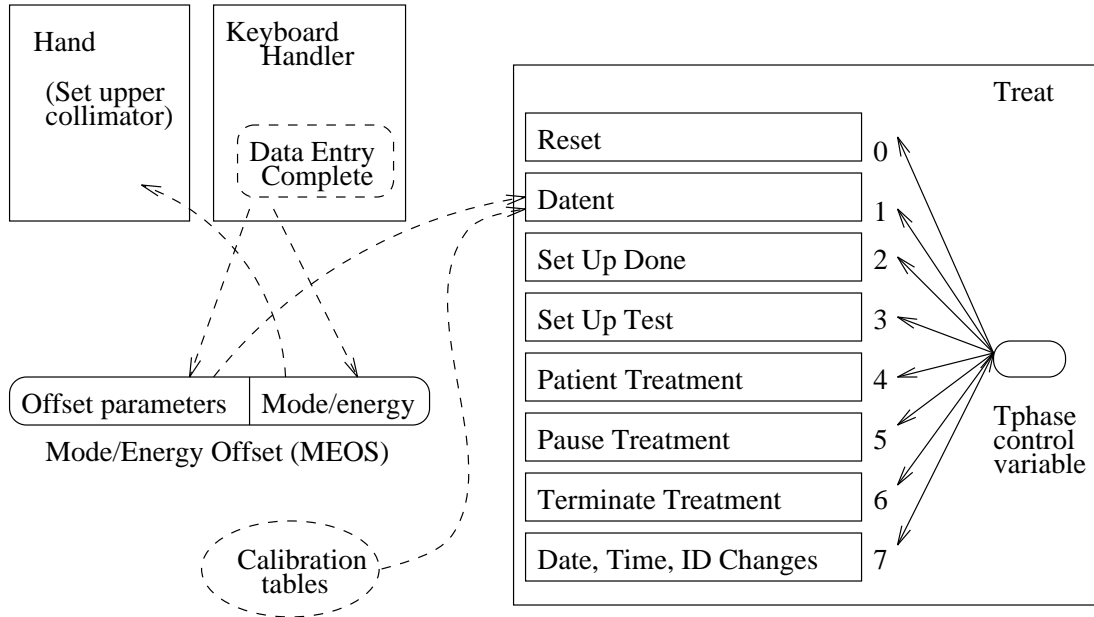
Figure 3: Tasks and subroutines in the code blamed for the Tyler accidents.

The treatment monitor task (Treat) controls the various phases of treatment by executing its eight subroutines. The treatment phase indicator variable (Tphase) is used to determine which subroutine should be executed (Figure 3). Following the execution of a particular subroutine, Treat reschedules itself.

But this is not the only problem. Upon exit from the Magnet subroutine, the data entry subroutine (Datent) checks the Data Entry Complete variable. If it indicates that data entry is complete, Datent sets Tphase to 3 and Datent is not entered again. If it is not set, Datent leaves Tphase unchanged, which means it will eventually be rescheduled. But the Data Entry Complete variable only indicates that the cursor has been down to the command line, not that it is still there. A potential race condition is set up. To fix this, AECL introduced another shared variable controlled by the keyboard handler task that indicates the cursor is not positioned on the command line. If this variable is set, then prescription entry is still in progress and the value of Tphase is left unchanged.
